# FOCUSED SITE INSPECTION PRIORITIZATION SITE EVALUATION REPORT

TARACORP INDUSTRIES
MCCOOK PLANT
7753 WEST 47TH STREET
McCOOK, ILLINOIS

Date Prepared: August 31, 1995

Prepared by: Ecology and Environment, Inc.

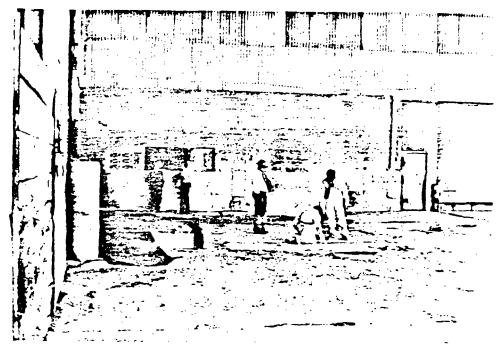
PHOTOGRAPH 3: TARACORP, McCook, Il.

TAT members Lorenz and Babusukumar prepare a composite sample of the concrete pad shown in Panorama 1. Mr. Ron Stoker of Moreco Energy, Inc., observes as George Webb of Taracorp and Walter Francis from the U.S. EPA peer into the interior of the building. Note the sign on the wall advising the use of respirators.

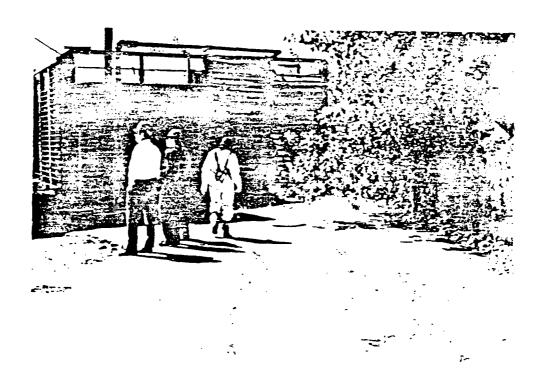
PHOTOGRAPH 5: TARACORP, McCook, II.

TAT member Babusukumar walks southwest towards a manhole cover near the cooling tower. A soil sample was collected in the southwest corner of the Taracorp property near a drainage ditch.

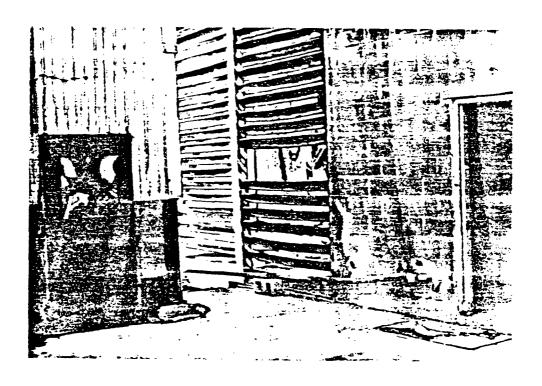
PHOTOGRAPH 6: TARACORP, McCook, II.

Most of the cooling tower had been demolished.
